Manhole Inspection Summary

Manhole # S21GG2028MH

Insp Date: **11/15/06 8:24 AM**

Location Address: **1123 BELLEMOORE RD**

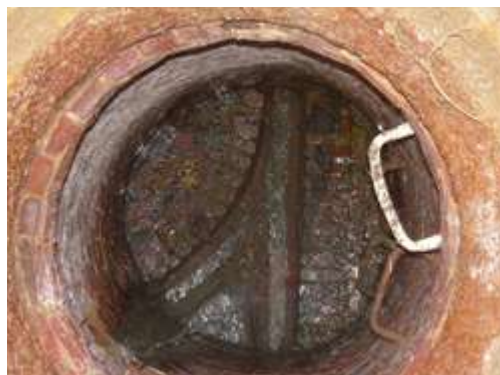
Top View

Corroded steps. Evidence of surcharge - Bench debris.

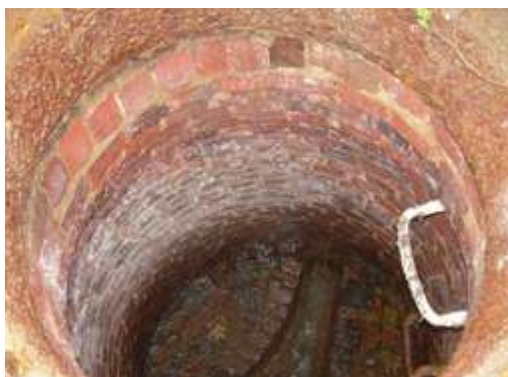
Defect

Adjustment deterioration and infiltration. Corbel and Barrel infiltration.

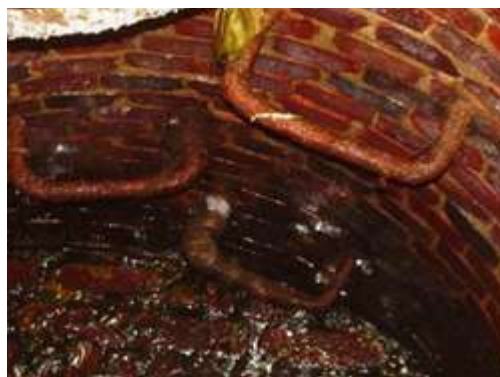
Defect

Evidence of surcharge - Bench debris. Corroded steps.

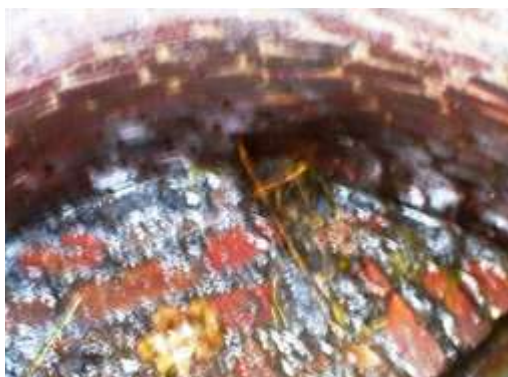
Defect

Barrel/Bench root intrusion.

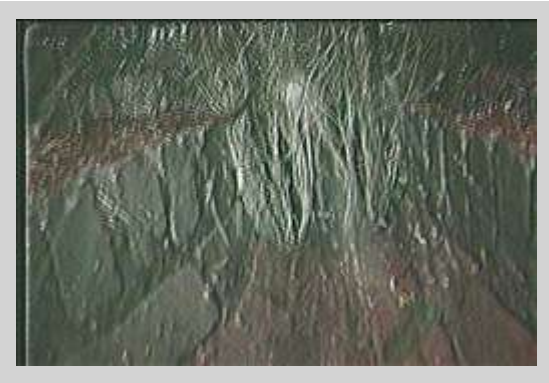
8 in. Circular Gravity Sewer Pipe Out @ 12 O'Clock

Roots above the pipe.

Infiltration: **None** Pipe Seal Cond: **Roots**

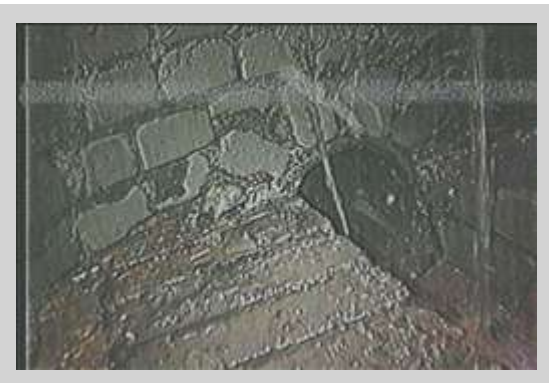
8 in. Circular Gravity Sewer Pipe In @ 6 O'Clock

Barrel deterioration, root intrusion and infiltration.

Infiltration: **Evidence** Pipe Seal Cond: **Unknown**

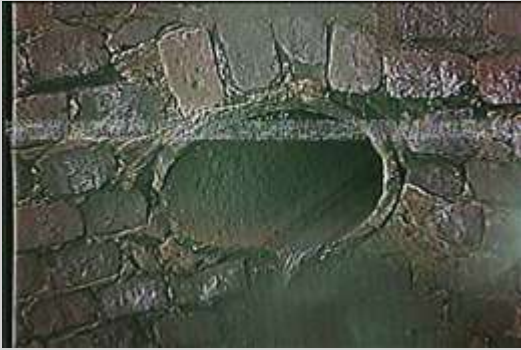
Pipe In @ 8 O'Clock

Corbel deterioration and infiltration.

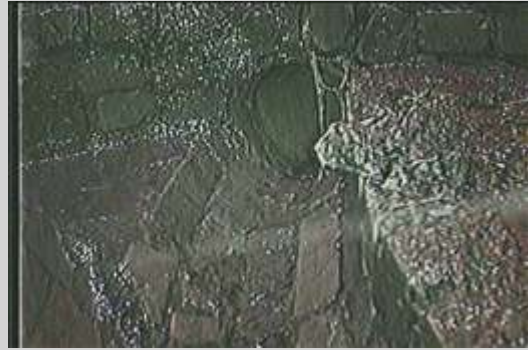
Drop In @ 8 O'Clock

Barrel deterioration and infiltration. Channel deterioration.

Drop Condition: **Partly Clogged**
